Florida Department of Transportation

Evaluation of ArmorGalv[®] under Salt Fog Exposure and Partial Immersion in Saltwater

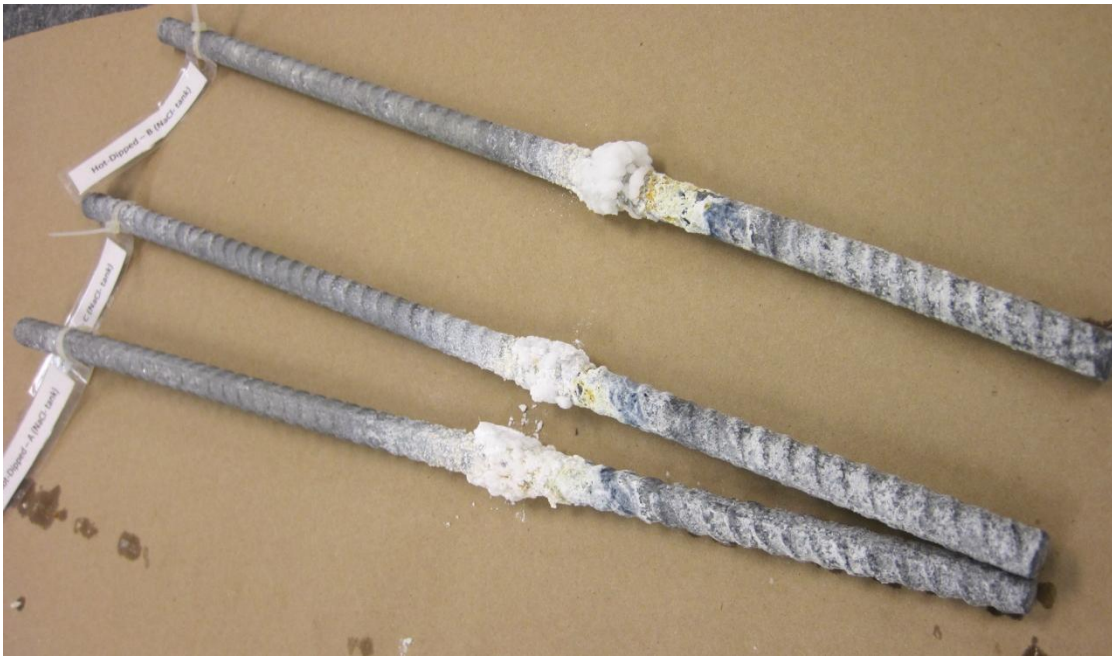
Figure 1 Traditional Hot Dipped galvanizing after 3700 hours partial immersion

Partial immersion in the 3.5% saltwater revealed performance differences between the two specimen types. There was some visible steel corrosion occurring on the hot dipped galvanized bars at the water line, with no visual corrosion in the submerged portion. (Figure 1.) In addition, copious amounts of zinc oxide was visible just above the water line indicating that as expected,

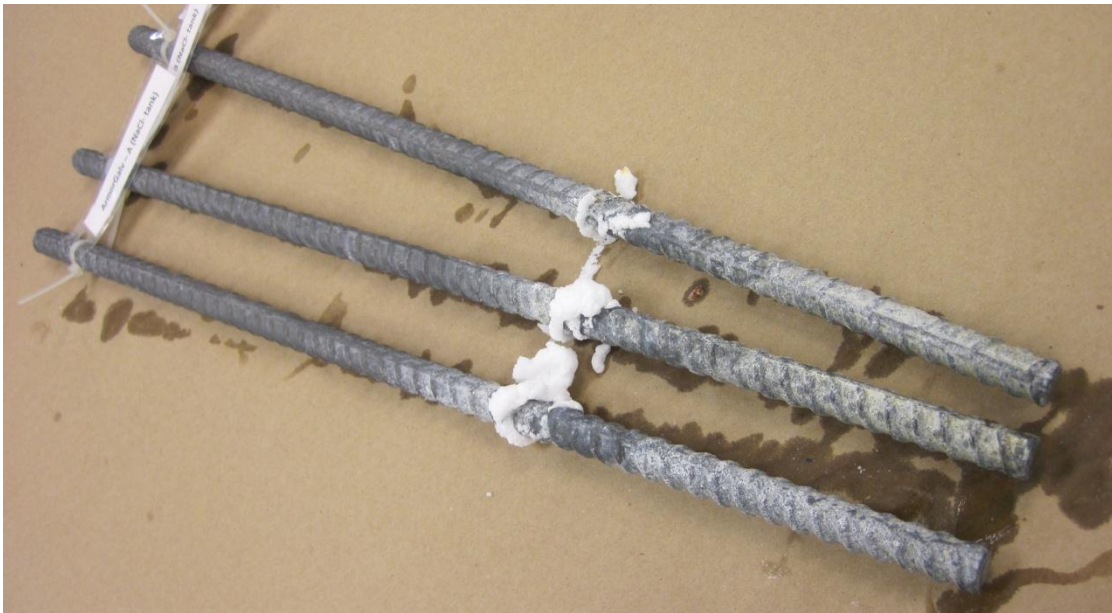
Figure 2 Armorgalv[®] process after 3700 hours of partial immersion

the zinc served as a sacrificial coating. The ArmorGalv[®] process showed no visual signs of steel corrosion. (Figure 2.)

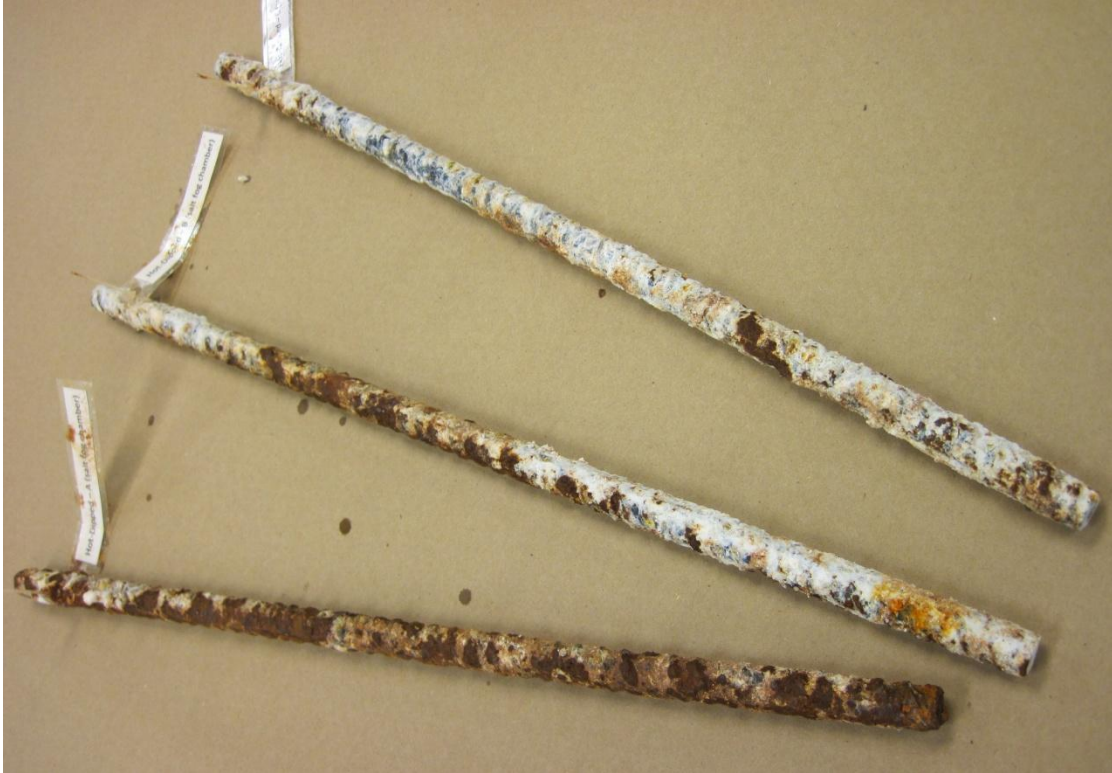
Figure 3 Traditional Hot Dipped galvanizing after 3000 hours in salt fog exposure

The salt fog exposure revealed large differences between the two specimen types. The hot dipped galvanized bars had visible corrosion over large portions of the bar surfaces. (Figure3.) The
